**Flood Control Project Maintenance  
Levee Inspections**

**Fall 2015 Levee Maintenance Deficiency Summary Report**

**San Joaquin River Basin**

**Reclamation District No. 2031 Elliot**

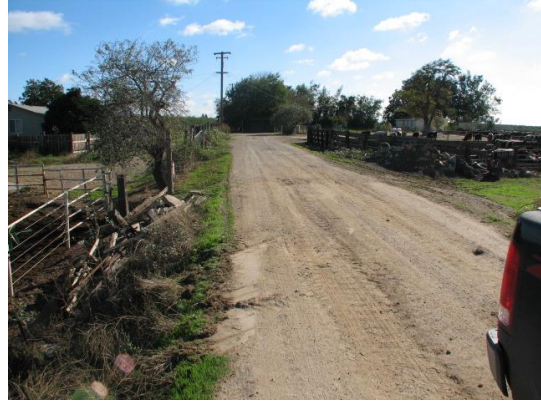
Photo 1 of 1 : FA\_2015\_RD2031\_307\_963\_20150910\_00037.jpg

LM Start	0.00	Rating **	M	Issue No.	963
LM End	0.06	Issue Type +	En	Location *	WS
Category	Earthen Levee			GPS Latitude/Longitude	
				Start	End
Item	Encroachments			37.710001 °	37.709951 °
				-121.155391 °	-121.156539 °
DWR ID	DWR_RD2031_01_s_2012_963				
Action/Comments					
Fence					
Inspector Comments: Wooden and steel livestock fence and debris limit access to slope.

Fall 2009 photo looking upstream at beginning of unit 1. Water side to the left.

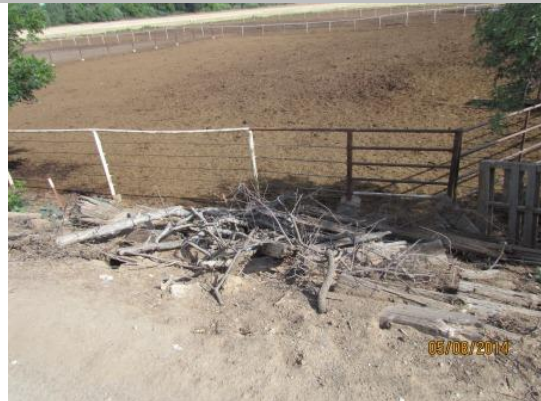
Photo 1 of 1 : FA\_2015\_RD2031\_307\_122\_20150910\_00032.jpg

LM Start	0.02	Rating **	U	Issue No.	122
LM End	0.02	Issue Type +	En	Location *	WS
Category	Earthen Levee			GPS Latitude/Longitude	
				Start	End
Item	Encroachments			37.710016 °	37.710016 °
				-121.155803 °	-121.155803 °
DWR ID	DWR_RD2031_01_s_2015_122				
Action/Comments					
Debris

View of the pile of debris on the waterside levee slope.

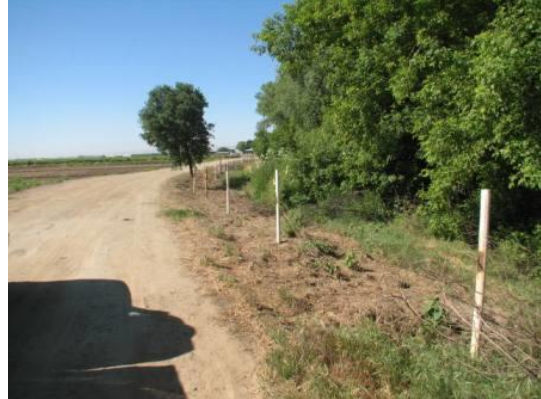
Photo 1 of 3 : FA\_2015\_RD2031\_307\_7\_20150910\_00007.jpg

LM Start	<b>0.34</b>	Rating **	M	Issue No.	<b>7 (cont)</b>
LM End	<b>0.52</b>	Issue Type +	En	Location *	WS

05/10/2011 Fence on waterside prevents access to waterside slope.

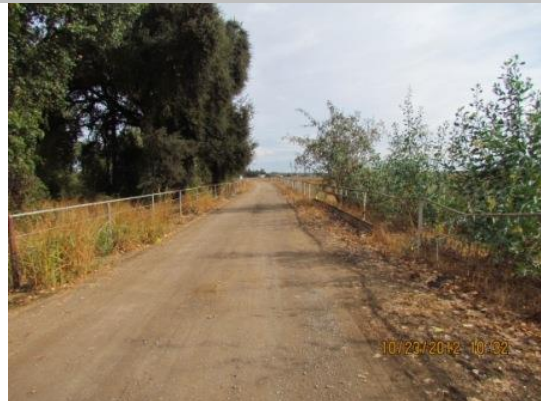
Photo 2 of 3 : FA\_2015\_RD2031\_307\_7\_20150910\_00008.jpg

View of fence obstructing access to waterside slope. Facing upstream.

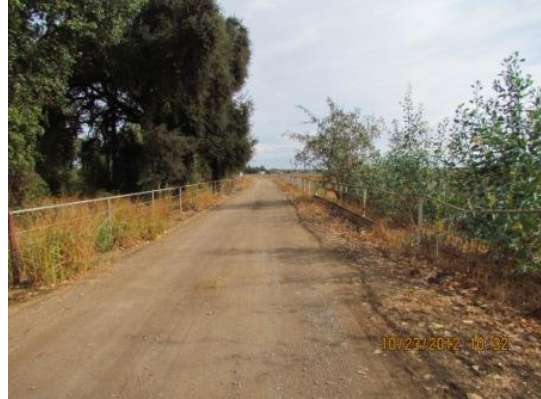
Photo 1 of 2 : FA\_2015\_RD2031\_307\_14\_20150910\_00012.jpg

LM Start	0.44	Rating **	M	Issue No.	14
LM End	0.53	Issue Type +	En	Location *	LS
Category	Earthen Levee			GPS Latitude/Longitude	
				Start	End
Item	Encroachments			37.704927 °	37.703788 °
				-121.158860 °	-121.159923 °
DWR ID	DWR_RD2031_01_f_2012_14				
Action/Comments					
Fence					
Inspector Comments: It appears the fence was completed without CVFPB approval.

View of fence on landside levee shoulder obstructing access to landside slope. Facing upstream.

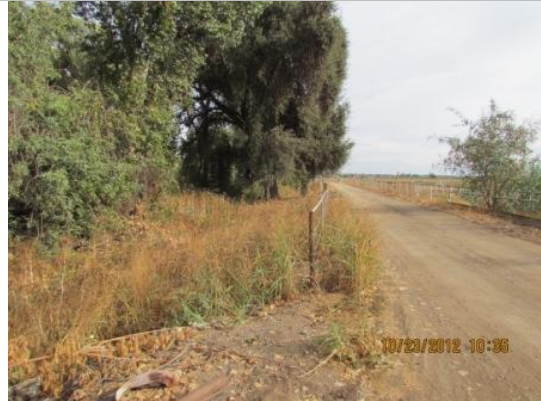
Photo 1 of 2 : FA\_2015\_RD2031\_307\_2\_20150910\_00002.jpg

View of vegetation on waterside slope. Facing upstream.

LM Start	0.48	Rating **	M	Issue No.	2
LM End	0.51	Issue Type +	Ma	Location *	WS
Category	Earthen Levee			GPS Latitude/Longitude	
				Start	End
Item	Vegetation			37.704385 °	37.704050 °
				-121.159217 °	-121.159578 °
DWR ID	DWR_RD2031_01_s_2012_2				
Action/Comments					
Remove the wild growth other than native grasses from the levee slopes. Inspector Comments: Remove vegetation 20 feet away from the levee crown.

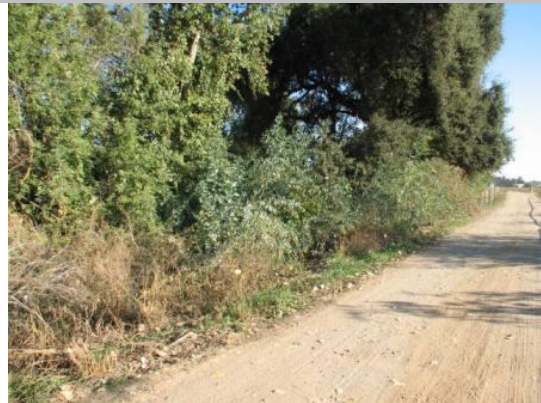
Photo 2 of 2 : FA\_2015\_RD2031\_307\_2\_20150910\_00003.jpg

LM Start	<b>0.48</b>	Rating **	M	Issue No.	<b>2 (cont)</b>
LM End	<b>0.51</b>	Issue Type +	Ma	Location *	WS

10/26/2011 Updated photo of waterside vegetation.

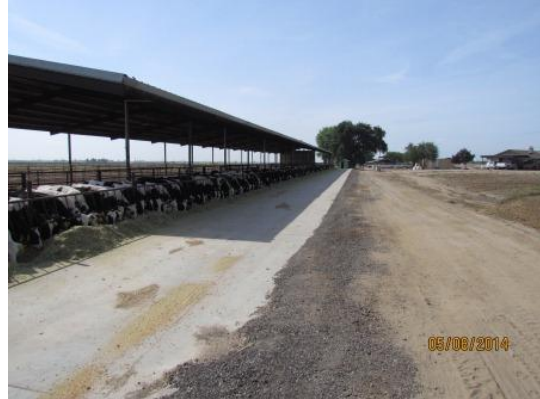
Photo 1 of 1 : FA\_2015\_RD2031\_307\_969\_20150910\_00038.jpg

LM Start	0.54	Rating **	U	Issue No.	969
LM End	0.65	Issue Type +	En	Location *	LS
Category	Earthen Levee			GPS Latitude/Longitude	
				Start	End
Item	Encroachments			37.703626 °	37.702648 °
				-121.159714 °	-121.160700 °
DWR ID	DWR_RD2031_01_s_2012_969				
Action/Comments					
Building					
Inspector Comments: Corrals and house on levee slope and crown.					
Demolition in progress.

View of the new coral at the landside levee slope and toe.

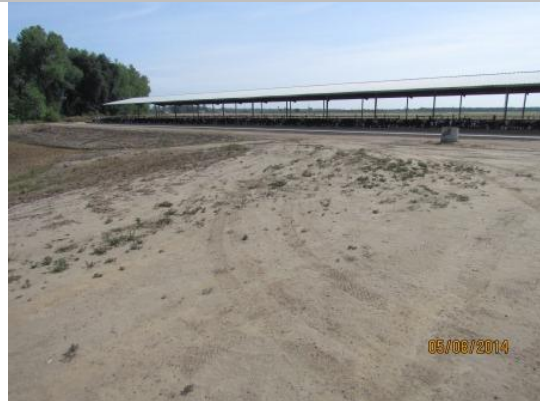
Photo 1 of 1 : FA\_2015\_RD2031\_307\_126\_20150910\_00034.jpg

LM Start	0.56	Rating **	M	Issue No.	126
LM End	0.56	Issue Type +	En	Location *	WS
Category	Earthen Levee			GPS Latitude/Longitude	
				Start	End
Item	Encroachments			37.703394 °	37.703394 °
				-121.159713 °	-121.159713 °
DWR ID	DWR_RD2031_01_s_2014_126				
Action/Comments					
Material Inspector Comments: Levee built up with material from adjacent field. Unpermitted. The landowner has contacted CVFPB and started the permitting process.

View of the material placed on the waterside levee slope to build up the levee and increase the levee crown.

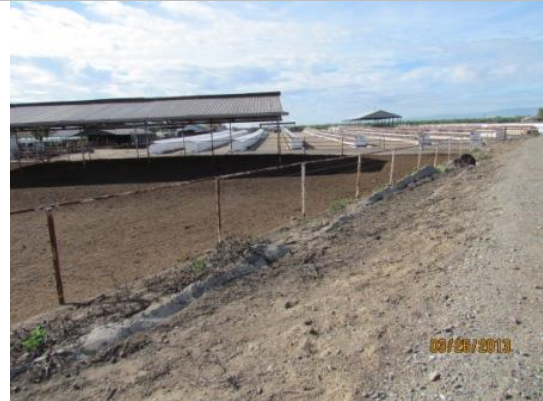
Photo 1 of 1 : FA\_2015\_RD2031\_307\_4\_20150910\_00006.jpg

LM Start	0.63	Rating **	M	Issue No.	4
LM End	0.72	Issue Type +	En	Location *	LS
Category	Earthen Levee			GPS Latitude/Longitude	
				Start	End
Item	Encroachments			37.702814 °	37.701875 °
				-121.160562 °	-121.161670 °
DWR ID	DWR_RD2031_01_s_2012_4				
Action/Comments					
Fence

View of the fence at the landside levee toe.

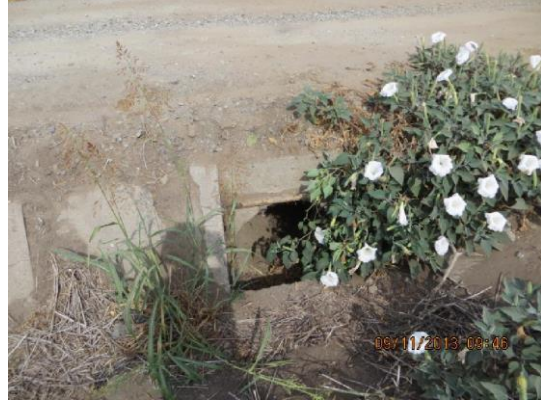
Photo 3 of 3 : UCIP\_FA\_2015\_1893.jpg

LM Start	0.72	Rating **	M	Issue No.	983 (cont)
LM End	0.72	Issue Type +	En	Location *	LS
Category	Supplemental			GPS Latitude/Longitude	
				Start	End
Item	DWR UCIP Field Study			37.701912 °	37.701912 °
				-121.161642 °	-121.161642 °
DWR ID					
Action/Comments					
Inspector Comments: FS_ID:20046					
DS_ID:20440					
EP_NO: N/A					
FS_HLM: 0.724					
Repair Type: Non-Urgent					
Crossing Status: Found

Concrete headwall and pipe at concrete channel along landside shoulder of levee.

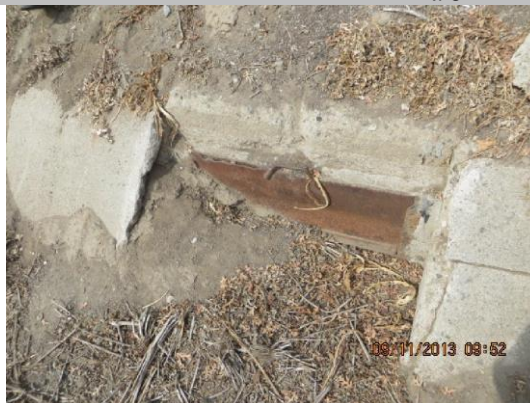
Photo 1 of 3 : UCIP\_FA\_2015\_1894.jpg

Inspector Comments: FS\_ID:20047  
DS\_ID:20441  
EP\_NO: N/A  
FS\_HLM: 0.752  
Repair Type: Non-Urgent  
Crossing Status: Found  
UCIP Comments: This pipe appears abandoned and if so, should be done so appropriately.  
FIELD\_STRUCT\_DESC: 15-inch corrugated metal pipe through levee 4.0 feet below crown. Flashboard slots on the landward side. Installed by USACE 1966. Originally included in the 1968 O&M manual.  
FS Date: 09/11/2013

Closed slidegate at concrete headwall in concrete channel on LS shoulder.

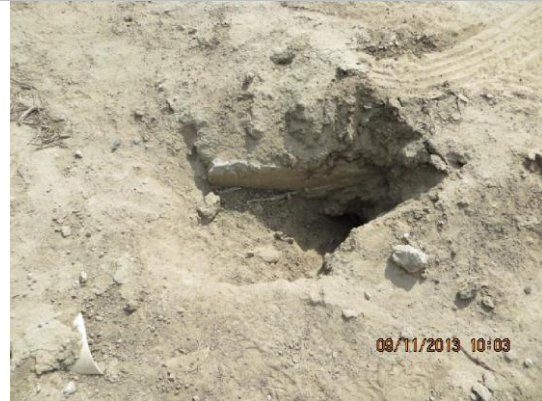
Photo 1 of 3 : UCIP\_FA\_2015\_1897.jpg

Action/Comments					
Inspector Comments: FS_ID:20049					
DS_ID:20443					
EP_NO: N/A					
FS_HLM: 0.807					
Repair Type: Non-Urgent					
Crossing Status: Found					
UCIP Comments: Pipe appears abandoned as WS slope is covered with soil. If abandoned, it should be done so properly.					
FIELD_STRUCT_DESC: 24-inch steel pipe through levee 2.0-feet below the crown. Concrete headwall on both sides of levee crown.					
FS Date: 09/11/2013

Concrete headwall on WS shoulder buried.

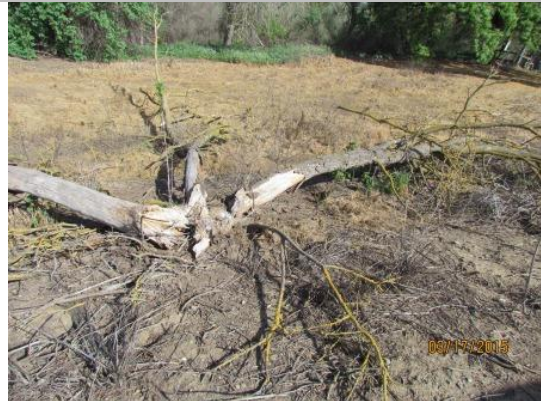
Photo 1 of 1 : FA\_2015\_RD2031\_307\_49\_20150910\_00026.jpg

LM Start	0.91	Rating **	N	Issue No.	49
LM End	0.91	Issue Type +	Ma	Location *	WS
Category	Earthen Levee			GPS Latitude/Longitude	
				Start	End
Item	Trim / Thin Trees			37.699790 °	37.699790 °
				-121.163730 °	-121.163730 °
DWR ID	DWR_RD2031_01_s_2015_49				
Action/Comments					
Tree stumps.

View of the tree stump on the waterside levee slope.

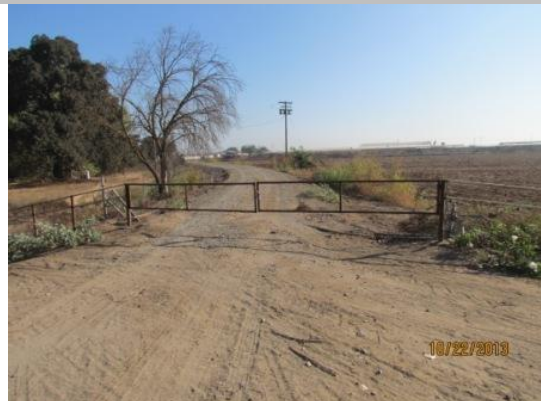
Photo 1 of 1 : FA\_2015\_RD2031\_307\_51\_20150910\_00028.jpg

LM Start	0.92	Rating **	M	Issue No.	51
LM End	0.92	Issue Type +	En	Location *	CR
Category	Earthen Levee			GPS Latitude/Longitude	
				Start	End
Item	Encroachments			37.699727 °	37.699727 °
				-121.163919 °	-121.163919 °
DWR ID	DWR_RD2031_01_f_2013_51				
Action/Comments					
Fence					
Inspector Comments: Unpermitted gate across levee crown.

View of the gate across levee crown.

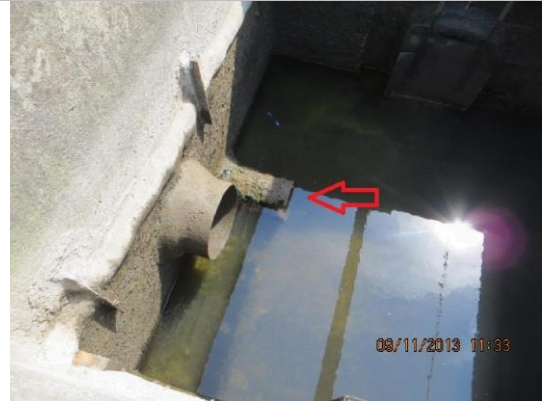
Photo 1 of 3 : UCIP\_FA\_2015\_1900.jpg

Inspector Comments: FS\_ID:20085  
 DS\_ID:20445  
 EP\_NO: N/A  
 FS\_HLM: 1.279  
 Repair Type: Non-Urgent  
 Crossing Status: Found  
 UCIP Comments: Pipe corroded through at distribution box. Appears abandoned and should be done so properly.  
 FIELD\_STRUCT\_DESC: 1 of 2: 12-inch steel pipe through the levee 3.3-feet below the crown. Pump missing from pile structure on the riverbank. Concrete distribution box on the landward side. Installed by USACE, 1966. Also included in 1968 O&M manual.  
 FS Date: 09/11/2013

Pipe visible inside concrete distribution box on LS shoulder.

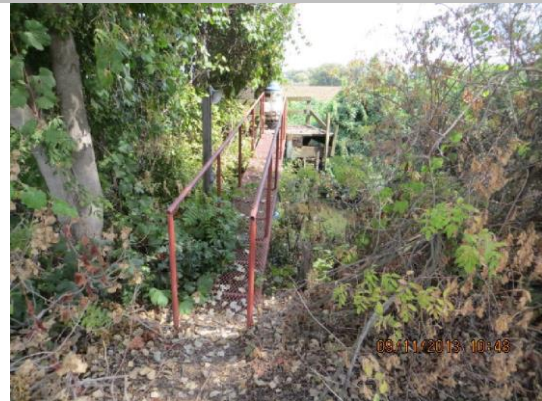
Photo 2 of 3 : UCIP\_FA\_2015\_1901.jpg

Pump on pier on WS slope.

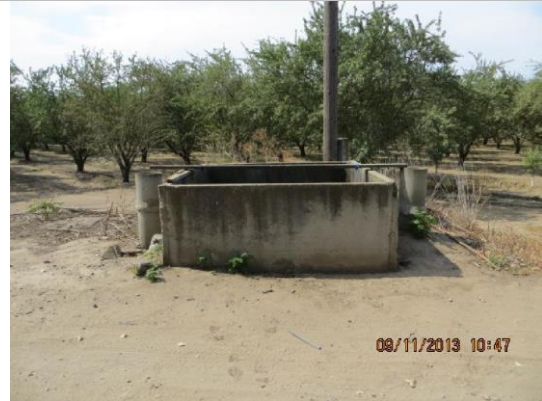
Photo 3 of 3 : UCIP\_FA\_2015\_1987.jpg

Concrete distribution box on LS shoulder.

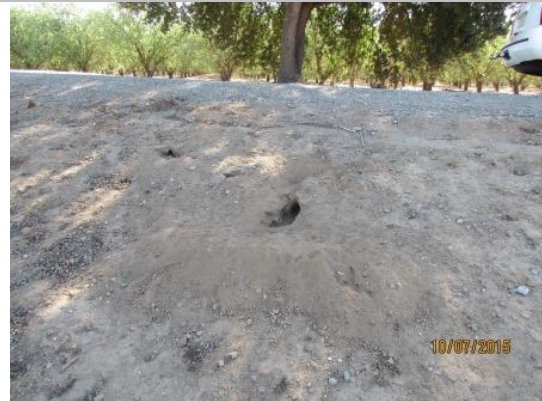
Photo 1 of 1 : FA\_2015\_RD2031\_307\_54\_20151008\_00054.jpg

View of the multiple rodent holes on the waterside levee slope.

LM Start	1.49	Rating **	M	Issue No.	54
LM End	1.49	Issue Type +	Ma	Location *	WS
Category	Earthen Levee			GPS Latitude/Longitude	
				Start	End
Item	Animal Control			37.699554 °	37.699554 °
				-121.173417 °	-121.173417 °
DWR ID	DWR_RD2031_01_f_2015_54				
Action/Comments					
Exterminate rodents and backfill and compact or grout burrows.

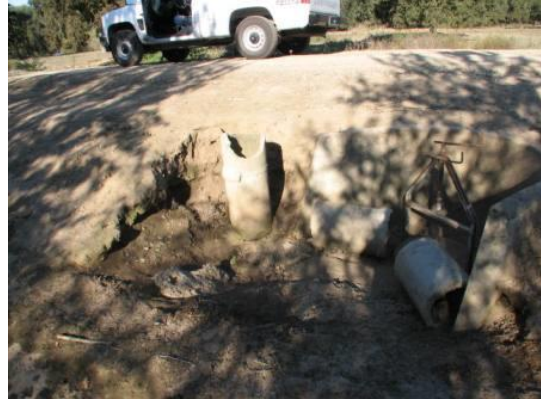
Photo 2 of 2 : FA\_2015\_RD2031\_307\_3\_20150910\_00005.jpg

LM Start	1.56	Rating **	U	Issue No.	3 (cont)
LM End	1.56	Issue Type +	Ma	Location *	LS
Category	Earthen Levee			GPS Latitude/Longitude	
				Start	End
Item	Erosion / Bank Caving			37.698776 °	37.698776 °
				-121.174327 °	-121.174327 °
DWR ID	DWR_RD2031_01_s_2012_3				
Action/Comments					
Note and monitor erosion site.					
Inspector Comments: Erosion is active around the irrigation standpipe.

10/26/2011 Active erosion into the levee prism around irrigation standpipe.

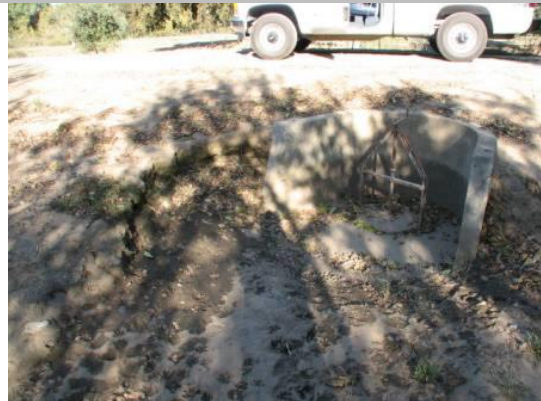
Photo 1 of 1 : FA\_2015\_RD2031\_307\_8\_20150910\_00010.jpg

LM Start	1.58	Rating **	U	Issue No.	8
LM End	1.58	Issue Type +	Ma	Location *	WS
Category	Earthen Levee			GPS Latitude/Longitude	
				Start	End
Item	Erosion / Bank Caving			37.698610 °	37.698610 °
				-121.174598 °	-121.174598 °
DWR ID	DWR_RD2031_01_s_2012_8				
Action/Comments					
Note and monitor erosion site.					
Inspector Comments: Active erosion is occurring around irrigation inlet.

10/26/2011 Active erosion shown around irrigation inlet.

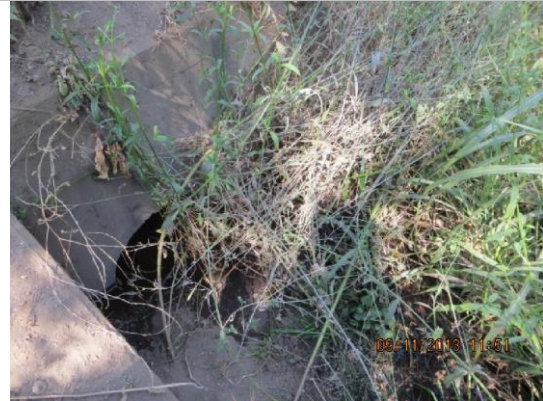
Photo 1 of 3 : UCIP\_FA\_2015\_2028.jpg

Concrete headwall at LS toe.

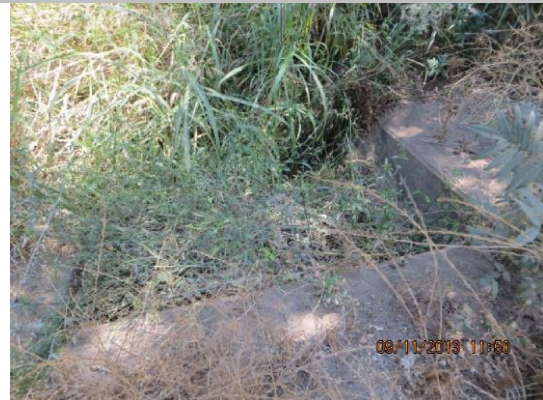
Photo 2 of 3 : UCIP\_FA\_2015\_2029.jpg

Concrete headwall on LS toe.

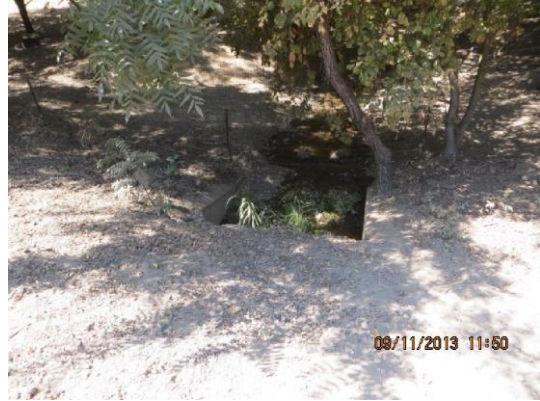
Photo 3 of 3 : UCIP\_FA\_2015\_2030.jpg

LM Start	1.78	Rating **	M	Issue No.	987 (cont)	
LM End	1.78	Issue Type +	En	Location *	LS	
Category	Supplemental			GPS Latitude/Longitude		
				Start	End	
Item	DWR UCIP Field Study			37.696958 °	37.696958	
				-121.177464 °	-121.177464	
DWR ID						
Action/Comments						
Inspector Comments: FS_ID:41354						
DS_ID:20470						
EP_NO: N/A						
FS_HLM: 1.796						
Repair Type: Non-Urgent						
Crossing Status: Found

Concrete headwall on WS toe.

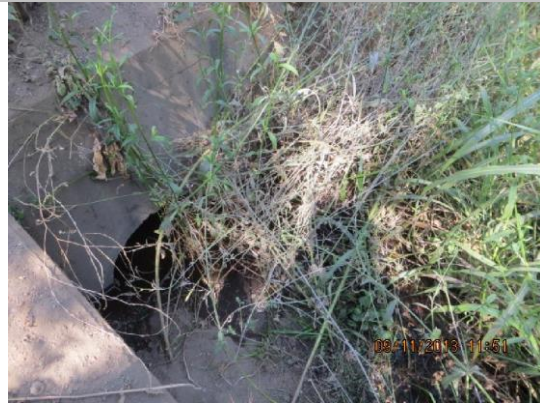
Photo 1 of 3 : UCIP\_FA\_2015\_2031.jpg

LM Start	1.78	Rating **	M	Issue No.	988
LM End	1.78	Issue Type +	En	Location *	LS
Category	Supplemental			GPS Latitude/Longitude	
				Start	End
Item	DWR UCIP Field Study			37.696943 °	37.696943 °
				-121.177470 °	-121.177470 °
DWR ID					
Action/Comments					
Inspector Comments: FS_ID:20092					
DS_ID:20447					
EP_NO: N/A					
FS_HLM: 1.797					
Repair Type: Non-Urgent					
Crossing Status: Found					
UCIP Comments: Silt buildup at inlet and outlet.					
FIELD_STRUCT_DESC: 2 of 2: 24-inch corrugated metal pipe through the levee 9.5-feet below the crown. Concrete "U"-shaped headwalls on both ends. Flap gate on the waterward end. Installed by USACE, 1966.					
Also included in the 1968 O&M manual.					
FS Date: 09/11/2013

Concrete U-shaped headwall on LS toe.

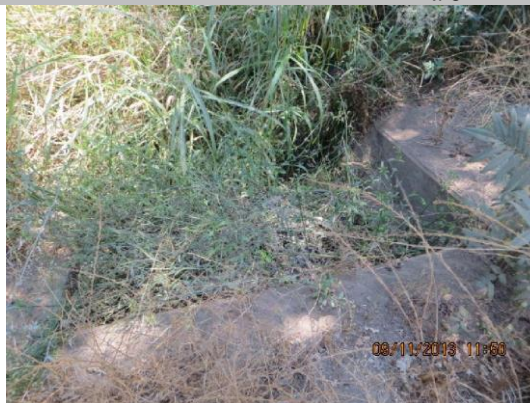
Photo 2 of 3 : UCIP\_FA\_2015\_2032.jpg

Concrete U-shaped headwall on LS toe.

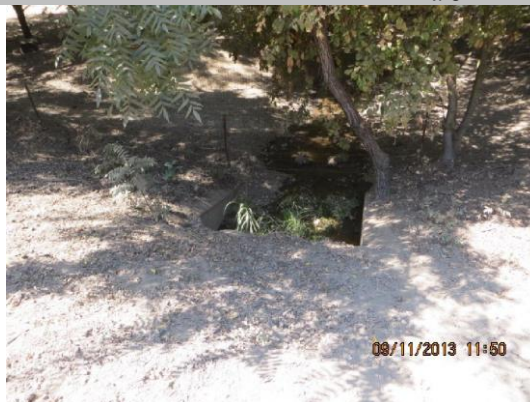
Photo 3 of 3 : UCIP\_FA\_2015\_2033.jpg

Concrete U-shaped headwall on WS toe.

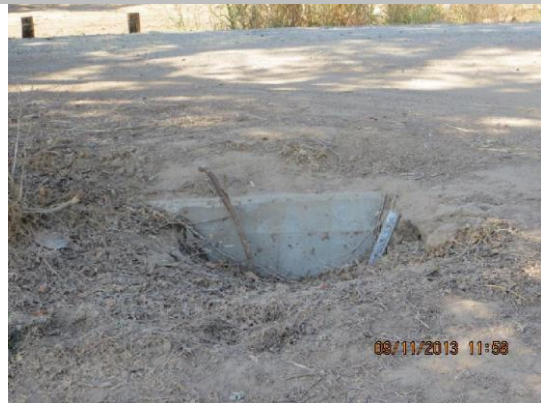
Photo 1 of 3 : UCIP\_FA\_2015\_1807.jpg

LM Start	1.86	Rating **	M	Issue No.	989
LM End	1.86	Issue Type +	En	Location *	WS
Category	Supplemental			GPS Latitude/Longitude	
				Start	End
Item	DWR UCIP Field Study			37.695737 °	37.695737 °
				-121.177533 °	-121.177533 °
DWR ID					
Action/Comments					
Inspector Comments: FS_ID:20109					
DS_ID:20448					
EP_NO: N/A					
FS_HLM: 1.881					
Repair Type: Non-Urgent					
Crossing Status: Found					
UCIP Comments: If abandoned it should be done so properly if not, the pipe should be cleared of soil blockage.					
FIELD_STRUCT_DESC: *Abandoned* 24-inch pipe through levee 6.8 feet below crown. Concrete headwalls on both ends. Flap gate on the waterward end. Installed by USACE, 1966.					
FS Date: 09/11/2013

Concrete headwall on LS shoulder.

Action/Comments					
Inspector Comments: FS_ID:20109 DS_ID:20448 EP_NO: N/A FS_HLM: 1.881 Repair Type: Non-Urgent Crossing Status: Found UCIP Comments: If abandoned it should be done so properly if not, the pipe should be cleared of soil blockage. FIELD_STRUCT_DESC: *Abandoned* 24-inch pipe through levee 6.8 feet below crown. Concrete headwalls on both ends. Flap gate on the waterward end. Installed by USACE, 1966. FS Date: 09/11/2013

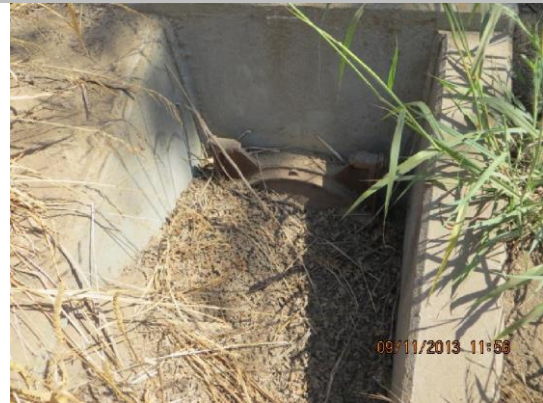
Photo 2 of 3 : UCIP\_FA\_2015\_1808.jpg

Flapgate on WS toe.

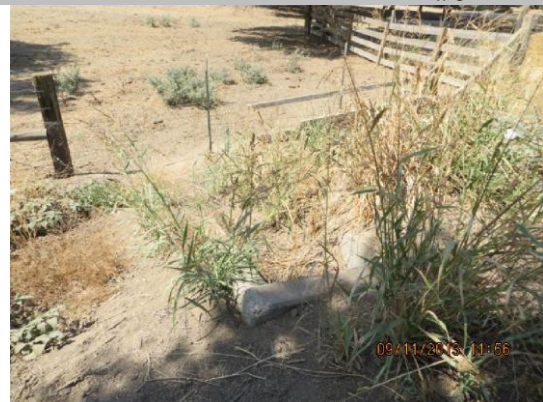
Photo 3 of 3 : UCIP\_FA\_2015\_1809.jpg

Concrete U-shaped headwall on WS toe.

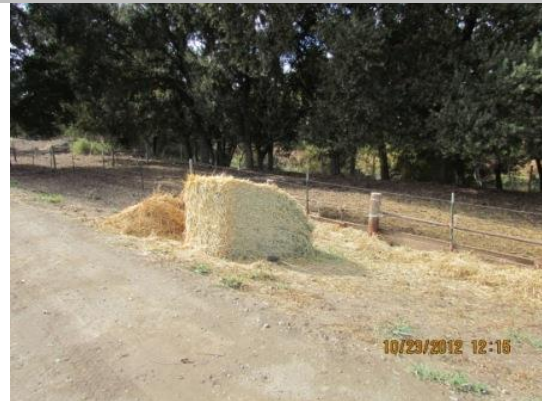
Photo 1 of 1 : FA\_2015\_RD2031\_307\_39\_20150910\_00021.jpg

LM Start	2.15	Rating **	M	Issue No.	39
LM End	2.15	Issue Type +	En	Location *	WS
Category	Earthen Levee			GPS Latitude/Longitude	
				Start	End
Item	Encroachments			37.691687 °	37.691687 °
				-121.178285 °	-121.178285 °
DWR ID	DWR_RD2031_01_f_2012_39				
Action/Comments					
Crops					
Inspector Comments: Hay bale on waterside levee slope.

View of hay bales at toe of levee on waterward side, facing downstream.  
05/02/2012

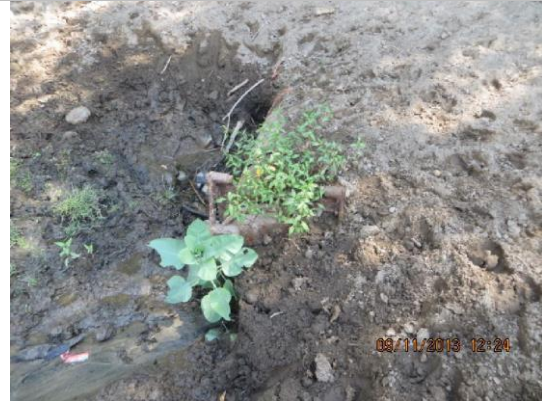
Photo 1 of 2 : UCIP\_FA\_2015\_1731.jpg

Inspector Comments: FS\_ID:43094  
 DS\_ID:24669  
 EP\_NO: N/A  
 FS\_HLM: 2.474  
 Repair Type: Urgent  
 Crossing Status: Found  
 UCIP Comments: Flapgate partially blocked by soil on WS toe. Good candidate for video inspection.  
 FIELD\_STRUCT\_DESC: 24-inch CMP stormdrain pipe through the levee at unknown depth. Flapgate on WS toe. Pipe may originate at concrete distribution box on LS toe.  
 FS Date: 09/11/2013

Flapgate partially blocked by soil on WS toe.

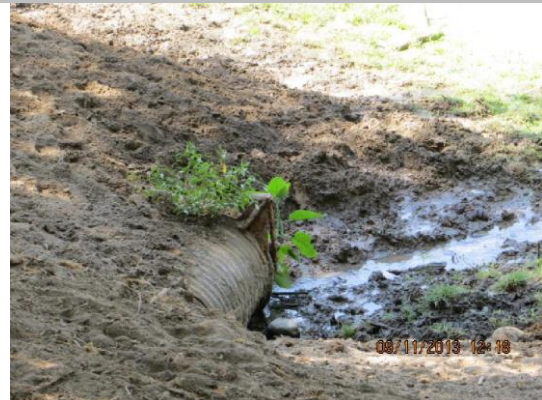
Photo 2 of 2 : UCIP\_FA\_2015\_2301.jpg

Flapgate and pipe visible on WS toe.

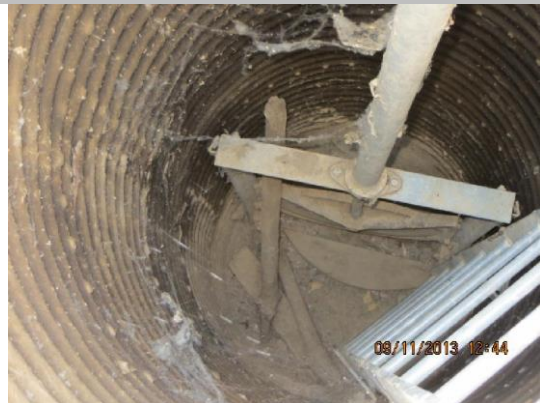
Photo 1 of 3 : UCIP\_FA\_2015\_1627.jpg

LM Start	3.08	Rating **	M	Issue No.	991
LM End	3.08	Issue Type +	En	Location *	WS
Category	Supplemental			GPS Latitude/Longitude	
				Start	End
Item	DWR UCIP Field Study			37.688297 °	37.688297 °
				-121.190865 °	-121.190865 °
DWR ID					
Action/Comments					
Inspector Comments: FS_ID:20449					
DS_ID:20451					
EP_NO: N/A					
FS_HLM: 3.115					
Repair Type: Non-Urgent					
Crossing Status: Found					
UCIP Comments: Pipe appears to be abandoned and if so should be done so properly.					
FIELD_STRUCT_DESC: 24-inch corrugated metal pipe through levee					
14.0 feet below crown. Slide gate in 36-inch corrugated metal pipe riser					
on the waterward slope. Originally included in the 1968 O&M manual.					
FS Date: 09/11/2013

Slide gate in CMP riser on WS slope.

Inspector Comments: FS\_ID:20449  
 DS\_ID:20451  
 EP\_NO: N/A  
 FS\_HLM: 3.115  
 Repair Type: Non-Urgent  
 Crossing Status: Found  
 UCIP Comments: Pipe appears to be abandoned and if so should be done so properly.  
 FIELD\_STRUCT\_DESC: 24-inch corrugated metal pipe through levee 14.0 feet below crown. Slide gate in 36-inch corrugated metal pipe riser on the waterward slope. Originally included in the 1968 O&M manual.  
 FS Date: 09/11/2013

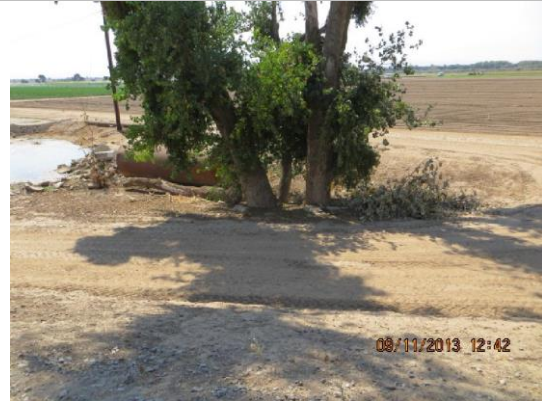
Photo 2 of 3 : UCIP\_FA\_2015\_1628.jpg

Pipe not visible on LS toe.

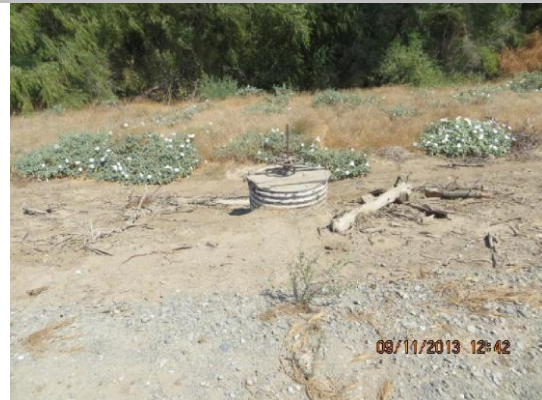
Photo 3 of 3 : UCIP\_FA\_2015\_1629.jpg

Slide gate in CMP riser on WS slope.

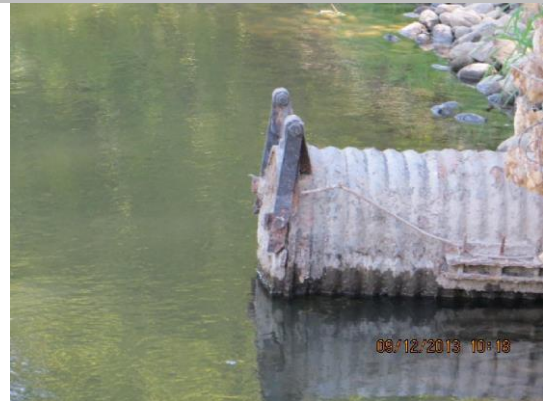
Photo 1 of 2 : UCIP\_FA\_2015\_2196.jpg

CMP pipe and flapgate visible at WS toe.

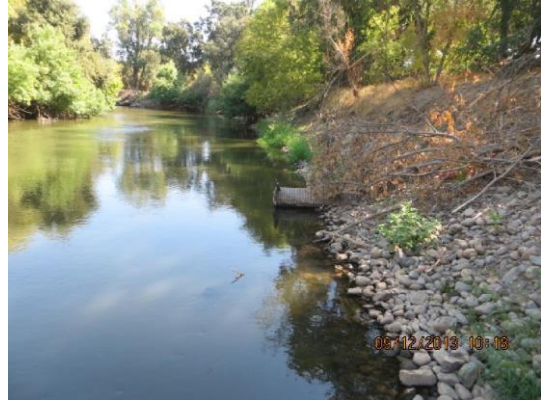
Photo 2 of 2 : UCIP\_FA\_2015\_2197.jpg

CMP pipe and flapgate visible at WS toe.

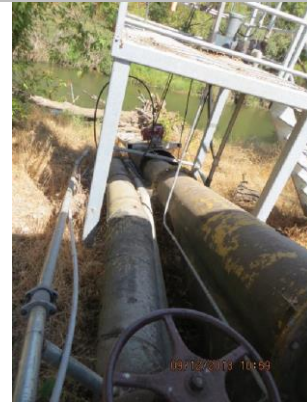
Photo 1 of 2 : UCIP\_FA\_2015\_2302.jpg

Pipe visible between larger irrigation pipes below slant pump on WS slope.

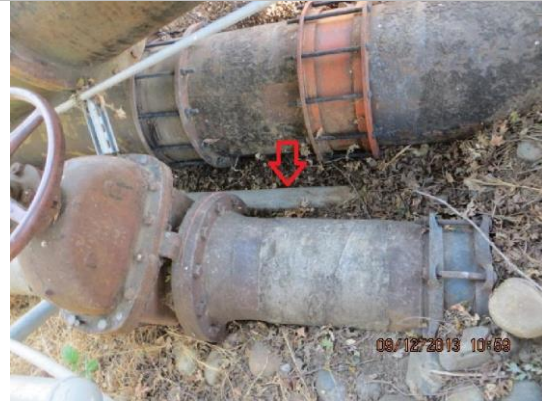
Photo 2 of 2 : UCIP\_FA\_2015\_2303.jpg

Pipe visible between larger irrigation pipes below slant pump on WS slope.

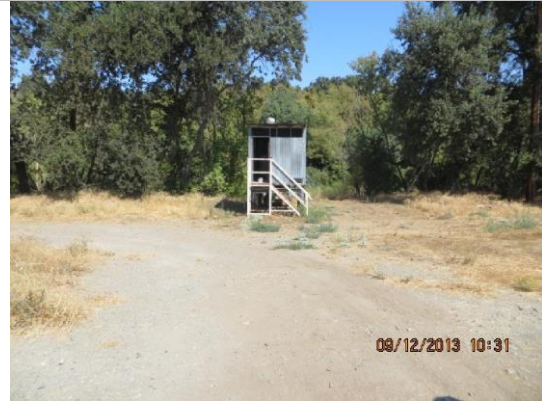
Photo 2 of 3 : UCIP\_FA\_2015\_1863.jpg

UCIP Comments: Siphon breaker missing from LS shoulder. Fish screen and pipe end covered in debris that may cause damage to pipe. FIELD\_STRUCT\_DESC: 1 of 2: 20-inch steel irrigation pipe through levee 3.9 feet below crown. Slant pump in pump house mounted on piles on the berm. Siphon breaker in corrugated metal pipe riser on the landward shoulder. Service pole on the landward slope. 5'X5' concrete distribution box on LS toe with flapgate. Originally included in the 1968 O&M manual.

Slant pump in pumphouse on WS berm.

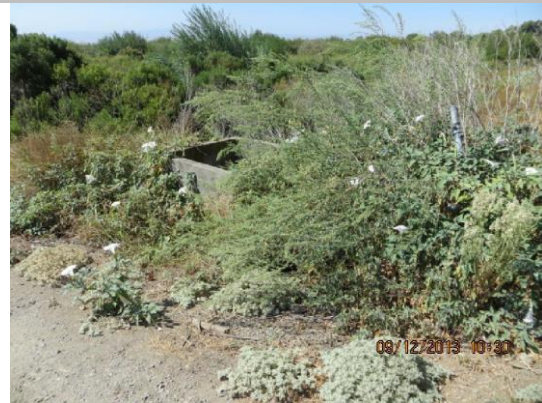
Photo 3 of 3 : UCIP\_FA\_2015\_1877.jpg

Concrete distribution box on LS slope.

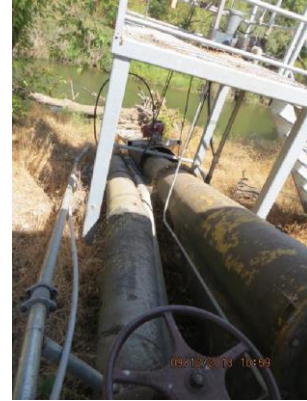
Photo 1 of 3 : UCIP\_FA\_2015\_2304.jpg

Pipe and appurtances visible on downstream side of and next to larger irrigation pipe.

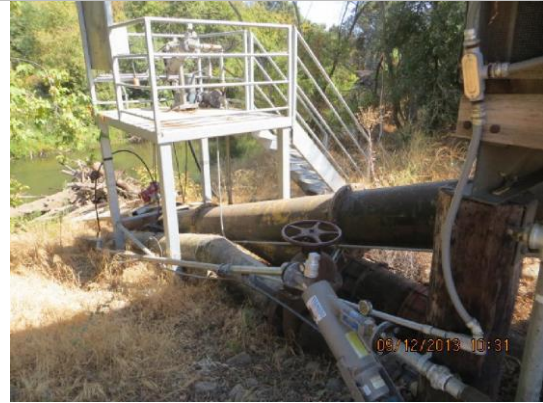
Photo 2 of 3 : UCIP\_FA\_2015\_2305.jpg

Pipe and appurtances visible on downstream side of and next to larger irrigation pipe.

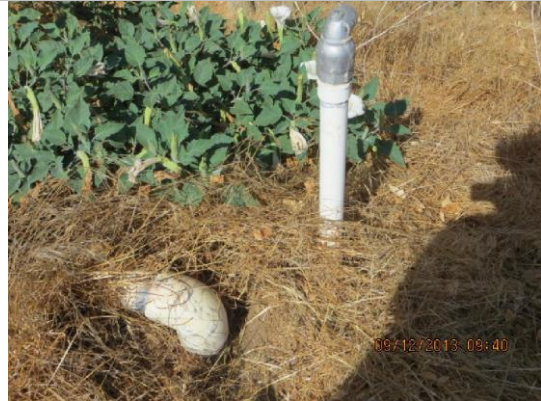
Photo 1 of 2 : UCIP\_FA\_2015\_2307.jpg

Pipe and vent visible on WS shoulder.

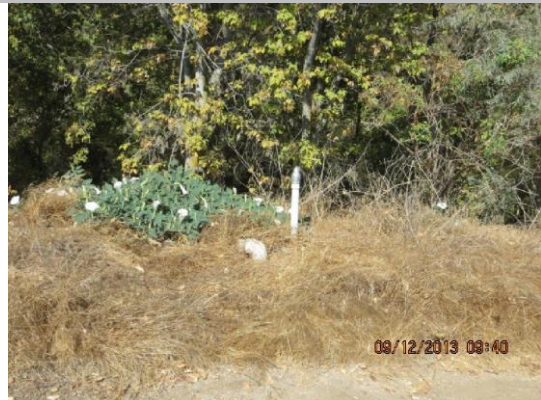
Photo 2 of 2 : UCIP\_FA\_2015\_2308.jpg

Pipe and vent visible on WS shoulder.

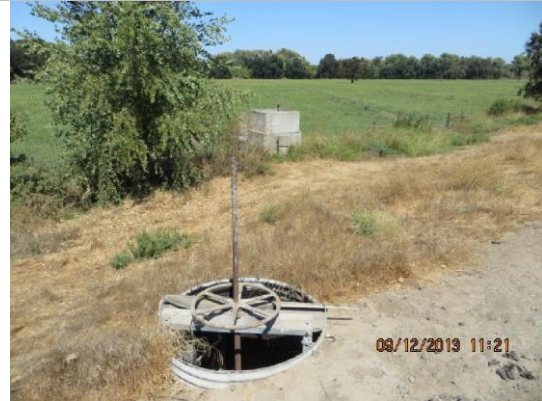
Photo 1 of 2 : UCIP\_FA\_2015\_1878.jpg

Inspector Comments: FS\_ID:20688  
 DS\_ID:20461  
 EP\_NO: N/A  
 FS\_HLM: 5.023  
 Repair Type: Non-Urgent  
 Crossing Status: Found  
 UCIP Comments: CMP riser on WS slope is missing lid and may be a hazard.  
 FIELD\_STRUCT\_DESC: 36-inch corrugated metal irrigation pipe through levee 11-feet below crown. Slide gate in 48-inch CMP riser on the waterward slope. 5'X5' Concrete distribution box 10 feet from the waterward toe. Underground irrigation system on the landside with concrete standpipes visible in field. Originally included in the 1968 O&M manual.  
 FS Date: 09/12/2013

Slide gate in CMP riser on WS shoulder with concrete distribution box visible in background at WS toe.

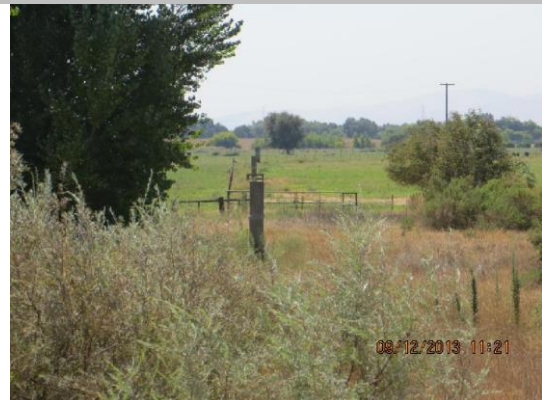
Photo 2 of 2 : UCIP\_FA\_2015\_1879.jpg

Concrete standpipes visible in field off LS toe.

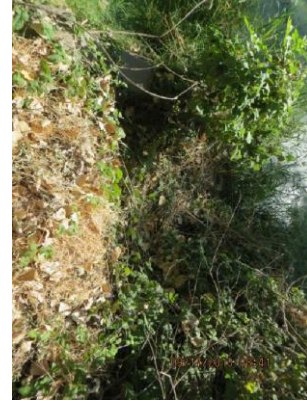
Photo 1 of 3 : UCIP\_FA\_2015\_1976.jpg

Concrete headwall on LS toe at edge of pond.

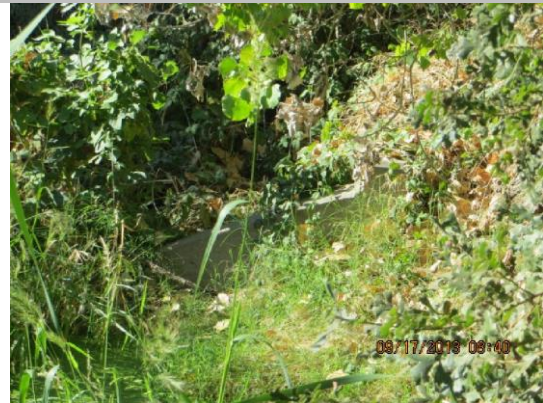
Photo 2 of 3 : UCIP\_FA\_2015\_1977.jpg

Concrete headwall on LS toe at edge of pond.

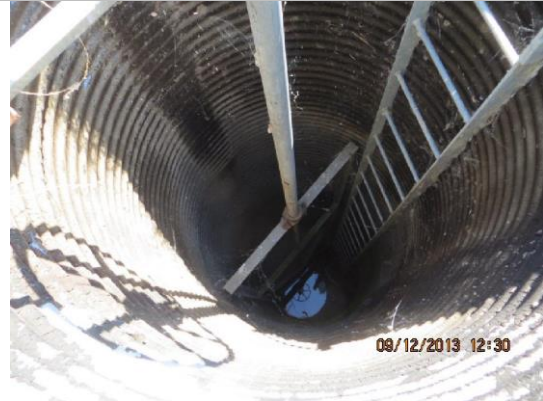
Photo 3 of 3 : UCIP\_FA\_2015\_1978.jpg

Slide gate in CMP riser on WS slope.

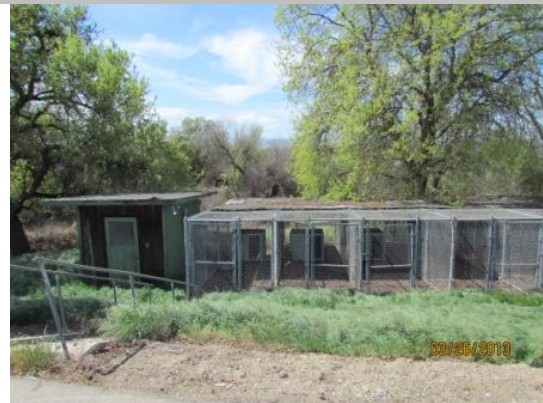
Photo 1 of 1 : FA\_2015\_RD2031\_308\_8\_20150910\_00005.jpg

LM Start	1.28	Rating **	M	Issue No.	8
LM End	1.28	Issue Type +	En	Location *	WS
Category	Earthen Levee			GPS Latitude/Longitude	
				Start	End
Item	Encroachments			37.649918 °	37.649918 °
				-121.221913 °	-121.221913 °
DWR ID	DWR_RD2031_02_s_2013_8				
Action/Comments					
Building

View of the structure at the waterside levee toe.

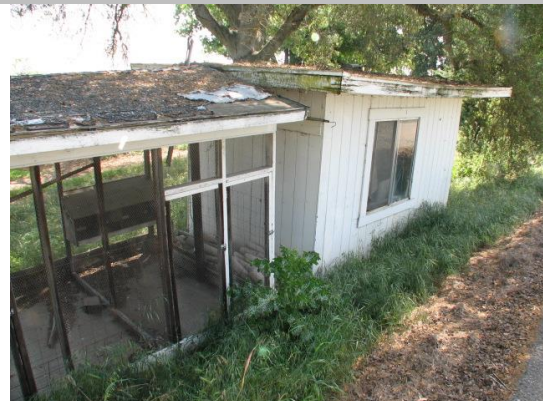
Photo 1 of 1 : FA\_2015\_RD2031\_308\_4\_20150910\_00004.jpg

LM Start	1.35	Rating **	U	Issue No.	4
LM End	1.35	Issue Type +	En	Location *	LS
Category	Earthen Levee			GPS Latitude/Longitude	
				Start	End
Item	Encroachments			37.648898 °	37.648898 °
				-121.221621 °	-121.221621 °
DWR ID	DWR_RD2031_02_s_2012_4				
Action/Comments					
Building

Small structure on levee slope.

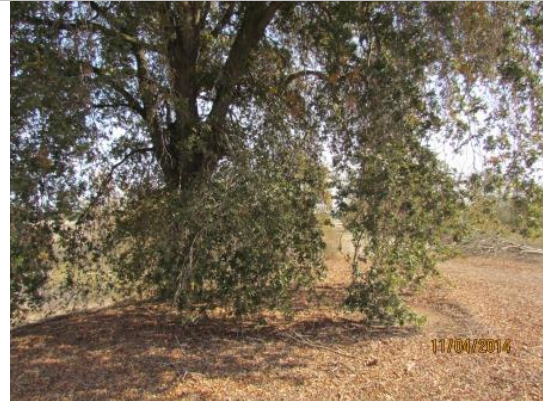
Photo 1 of 1 : FA\_2015\_RD2031\_308\_25\_20150910\_00011.jpg

View of the overgrown tree obstructing visibility and access of the landside levee slope.

LM Start	2.01	Rating **	M	Issue No.	25
LM End	2.01	Issue Type +	Ma	Location *	LS
Category	Earthen Levee			GPS Latitude/Longitude	
				Start	End
Item	Trim / Thin Trees			37.640874 °	37.640874 °
				-121.223870 °	-121.223870 °
DWR ID	DWR_RD2031_02_f_2014_25				
Action/Comments					
Trim trees to at least five feet above ground level.

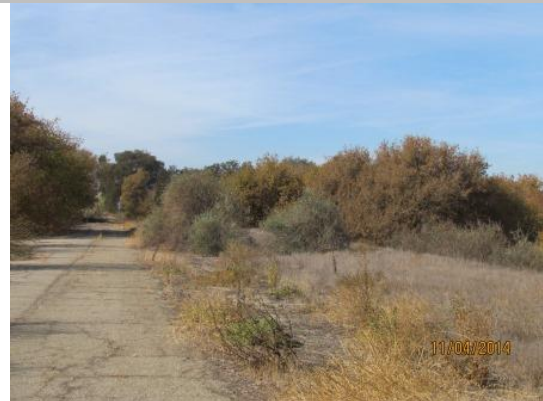
Photo 1 of 1 : FA\_2015\_RD2031\_308\_21\_20150910\_00009.jpg

View of overgrown vegetation on the levee crown.

LM Start	2.14	Rating **	M	Issue No.	21
LM End	2.14	Issue Type +	Ma	Location *	CR
Category	Earthen Levee			GPS Latitude/Longitude	
				Start	End
Item	Vegetation			37.640632 °	37.640632 °
				-121.221539 °	-121.221539 °
DWR ID	DWR_RD2031_02_f_2014_21				
Action/Comments					
Remove the wild growth other than native grasses from the levee slopes.

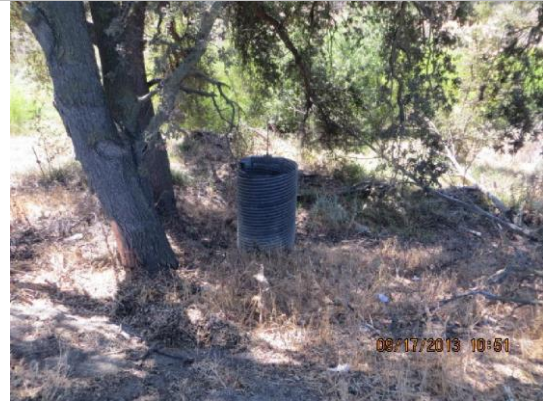
Photo 1 of 3 : UCIP\_FA\_2015\_2002.jpg

LM Start	2.72	Rating **	M	Issue No.	968
LM End	2.72	Issue Type +	En	Location *	WS
Category	Supplemental			GPS Latitude/Longitude	
				Start	End
Item	DWR UCIP Field Study			37.637760 °	37.637760 °
				-121.211743 °	-121.211743 °
DWR ID					
Action/Comments					
Inspector Comments: FS_ID:20713 DS_ID:20490 EP_NO: 11758 FS_HLM: 2.747 Repair Type: Non-Urgent Crossing Status: Found UCIP Comments: Pipe rusted through and failing at WS toe. Good indicator of internal condition of pipe. Good candidate for video inspection. FIELD_STRUCT_DESC: 24-inch corrugated metal gravity drain pipe through levee 17.0 feet below crown. 20-inch steel pipe and 1.25-inch galvanized conduit sleeved through pipe. Annular space has been pressure grouted. 24-inch pipe originally included in the 1968 O&M manual. Slide gate in 48-inch CMP riser on LS slope. 36-inch concrete standpipe at LS toe with pump on 48-inch steel standpipe. 20-inch and 1.5-inch pipes installed under Permit No. 11758, 1976. FS Date: 09/17/2013

Slide gate in 48-inch CMP riser on WS slope.

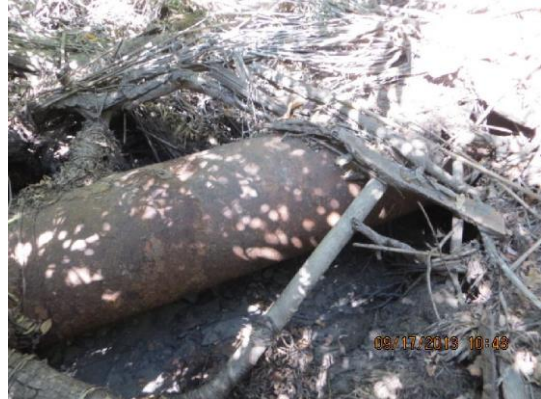
Photo 3 of 3 : UCIP\_FA\_2015\_2004.jpg

LM Start	2.72	Rating **	M	Issue No.	968 (cont)	
LM End	2.72	Issue Type +	En	Location *	WS	
Category	Supplemental			GPS Latitude/Longitude		
				Start	End	
Item	DWR UCIP Field Study			37.637760 °	37.637760 °	
				-121.211743 °	-121.211743 °	
DWR ID						
Action/Comments						
Inspector Comments: FS_ID:20713						
DS_ID:20490						
EP_NO: 11758						
FS_HLM: 2.747						
Repair Type: Non-Urgent						
Crossing Status: Found

Pipe visible on LS toe.

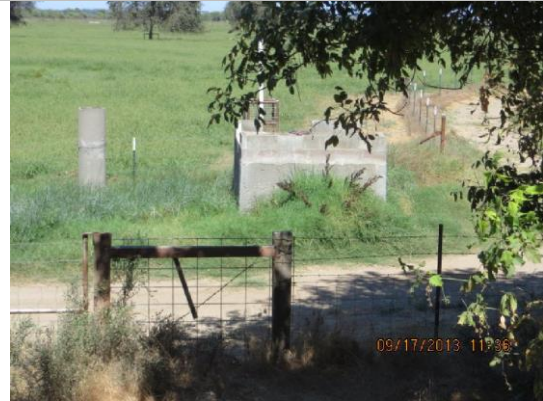
Photo 1 of 3 : UCIP\_FA\_2015\_2008.jpg

Inspector Comments: FS\_ID:20719  
 DS\_ID:20492  
 EP\_NO: N/A  
 FS\_HLM: 3.242  
 Repair Type: Non-Urgent  
 Crossing Status: Found  
 UCIP Comments: Annular space between 20-inch and 24-inch pipe not grouted.  
 FIELD\_STRUCT\_DESC: 24-inch steel pipe through levee 8.0 feet below crown. Pump on pile structure in river. 20-inch steel pipe sleeved through 24-inch. 4'X11' concrete distribution box on LS toe. 2-inch electrical conduit at same location. Originally included in the 1968 O&M manual.  
 FS Date: 09/17/2013

Concrete distribution box off LS toe.

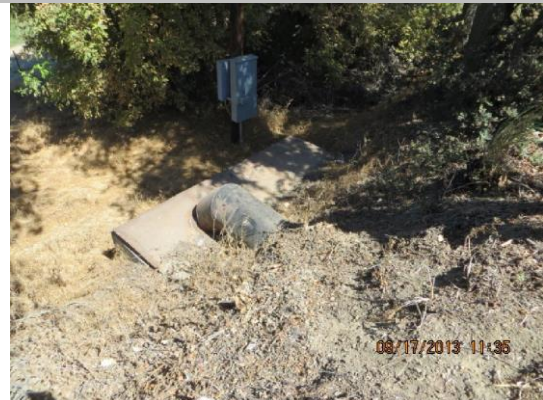
Photo 2 of 3 : UCIP\_FA\_2015\_2009.jpg

Concrete distribution box on LS slope.

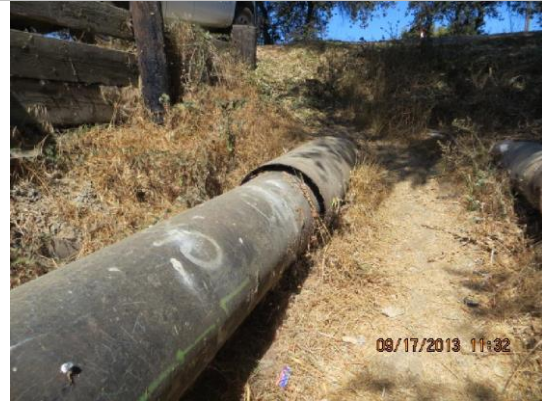
Photo 3 of 3 : UCIP\_FA\_2015\_2010.jpg

24-inch with 20-inch sleeved through it.

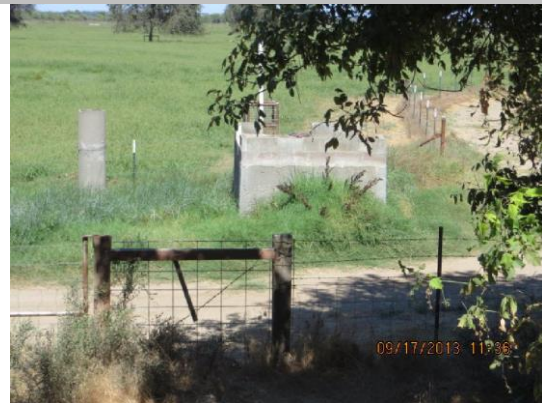
Photo 1 of 3 : UCIP\_FA\_2015\_2005.jpg

LM Start	3.21	Rating **	M	Issue No.	970
LM End	3.21	Issue Type +	En	Location *	LS
Category	Supplemental			GPS Latitude/Longitude	
				Start	End
Item	DWR UCIP Field Study			37.638186 °	37.638186 °
				-121.202895 °	-121.202895 °
DWR ID					
Action/Comments					
Inspector Comments: FS_ID:20718					
DS_ID:20493					
EP_NO: N/A					
FS_HLM: 3.243					
Repair Type: Non-Urgent					
Crossing Status: Found					
UCIP Comments: Pipe appears abandoned and if so should be done so properly.					
FIELD_STRUCT_DESC: 16-inch steel pipe through levee 7.5 feet below crown. Pump on pile structure in river. 4'X11' concrete distribution box on LS slope. 6'X6' concrete distribution box off LS toe. Originally included in the 1968 O&M manual.					
FS Date: 09/17/2013

Concrete distribution box off LS toe.

Inspector Comments: FS\_ID:20718  
 DS\_ID:20493  
 EP\_NO: N/A  
 FS\_HLM: 3.243  
 Repair Type: Non-Urgent  
 Crossing Status: Found  
 UCIP Comments: Pipe appears abandoned and if so should be done so properly.  
 FIELD\_STRUCT\_DESC: 16-inch steel pipe through levee 7.5 feet below crown. Pump on pile structure in river. 4'X11' concrete distribution box on LS slope. 6'X6' concrete distribution box off LS toe.  
 Originally included in the 1968 O&M manual.  
 FS Date: 09/17/2013

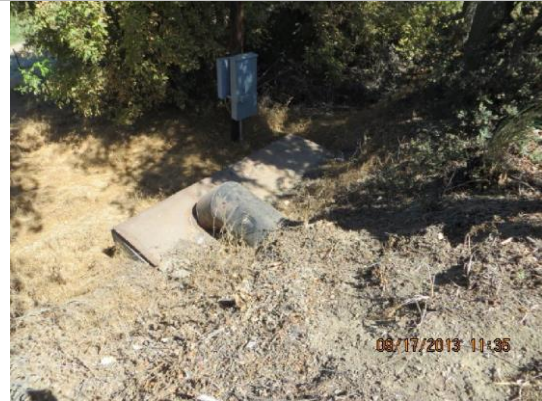
Photo 2 of 3 : UCIP\_FA\_2015\_2006.jpg

concrete distribution box on LS toe.

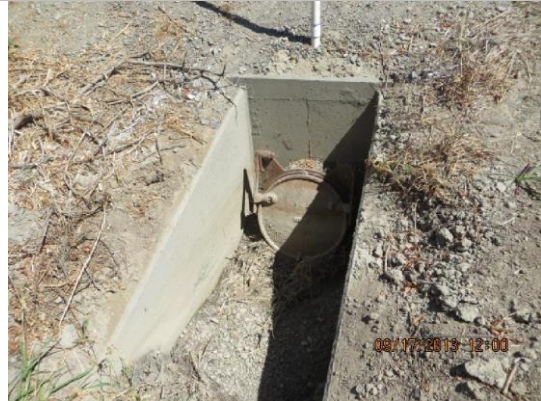
Photo 1 of 3 : UCIP\_FA\_2015\_2011.jpg

LM Start	3.84	Rating **	U	Issue No.	971
LM End	3.84	Issue Type +	En	Location *	LS
Category	Supplemental			GPS Latitude/Longitude	
				Start	End
Item	DWR UCIP Field Study			37.637924 °	37.637924 °
				-121.191600 °	-121.191600 °
DWR ID					
Action/Comments					
Inspector Comments: FS_ID:43095					
DS_ID:20496					
EP_NO: N/A					
FS_HLM: 3.876					
Repair Type: Urgent					
Crossing Status: Found

Flapgate on WS toe.

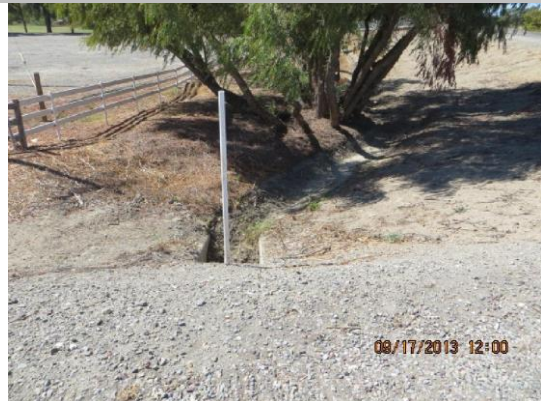
Photo 2 of 3 : UCIP\_FA\_2015\_2012.jpg

Concrete headwall on WS toe.

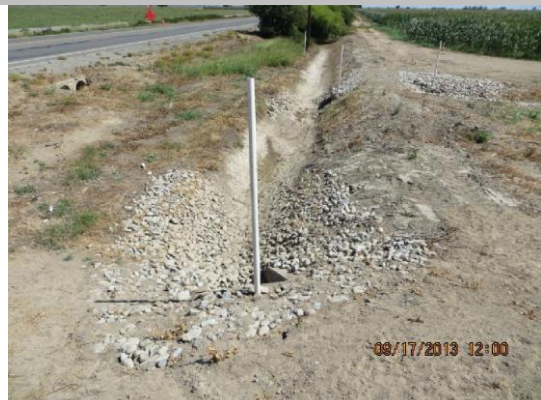
Photo 3 of 3 : UCIP\_FA\_2015\_2013.jpg

Concrete headwall on LS toe.

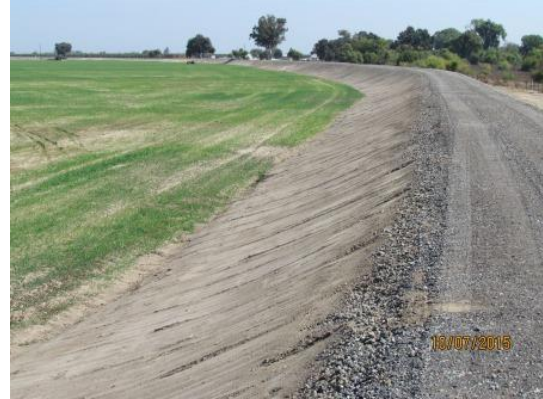
Photo 1 of 1 : FA\_2015\_RD2031\_308\_20\_20151008\_00022.jpg

View of the acceptable vegetation control on the landside levee slope.

LM Start	4.25	Rating **	A	Issue No.	20
LM End	4.25	Issue Type +	Ma	Location *	LS
Category	Earthen Levee			GPS Latitude/Longitude	
				Start	End
Item	Vegetation			37.632161 °	37.632161 °
				-121.190290 °	-121.190290 °
DWR ID	DWR_RD2031_02_f_2015_20				
Action/Comments					
Control annual grass and weeds on the levee slopes and easements.

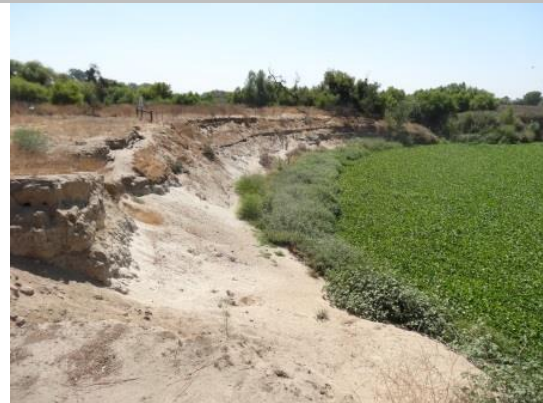
Photo 1 of 3 : SJR2015\_RD2031U02RM78.70\_1.jpg

LM Start	4.29	Rating **	A/W	Issue No.	1
LM End	4.33	Issue Type +	Ma	Location *	WS
Category	Supplemental			GPS Latitude/Longitude	
				Start	End
Item	DWR Erosion Survey			37.631716 °	37.631716 °
				-121.189370 °	-121.189370 °
DWR ID					
Action/Comments					
Inspector Comments: 08/19/2015: No significant change observed. 7/17/2014: The erosion has slightly expanded toward levee toe at two pocket locations. 09/10/2013: The site has been visited. The erosion has expanded toward levee crest at two pocket locations. 07/18/2012: No significant change observed on the site. 08/18/2011: No significant change observed on the site. Dead trees and animal activities are visible. The closest point of the erosion site to the levee toe is about 100 ft. 10/19/2010: There is active scouring occurring on the bank due to the nature of the flow and the lack of armor protection. There is also a fallen log immediately downstream of where the erosion has occurred and is protruding outward, possibly creating an eddy and scouring the bank. With the remaining 100-foot wide berm, the levee prism is not yet affected. However, the bank will continue to degrade, and eventually intrude into the levee prism if no protection is put in place. Erosion site is recommended for annual assessment and monitoring during flood events. [2015 Site ID:RD2031U02RM78.7]

Looking downstream.

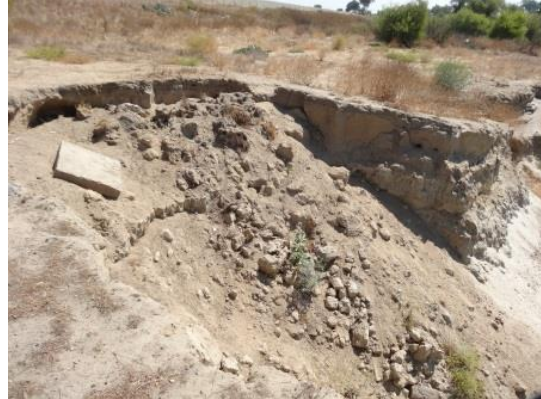
Photo 2 of 3 : SJR2015\_RD2031U02RM78.70\_2.jpg

Inspector Comments: 08/19/2015: No significant change observed.  
 7/17/2014: The erosion has slightly expanded toward levee toe at two pocket locations.  
 09/10/2013: The site has been visited. The erosion has expanded toward levee crest at two pocket locations.  
 07/18/2012: No significant change observed on the site.  
 08/18/2011: No significant change observed on the site. Dead trees and animal activities are visible. The closest point of the erosion site to the levee toe is about 100 ft.  
 10/19/2010: There is active scouring occurring on the bank due to the nature of the flow and the lack of armor protection. There is also a fallen log immediately downstream of where the erosion has occurred and is protruding outward, possibly creating an eddy and scouring the bank. With the remaining 100-foot wide berm, the levee prism is not yet affected. However, the bank will continue to degrade, and eventually intrude into the levee prism if no protection is put in place. Erosion site is recommended for annual assessment and monitoring during flood events. [2015 Site ID:RD2031U02RM78.7]

Close view of the pocket erosion.

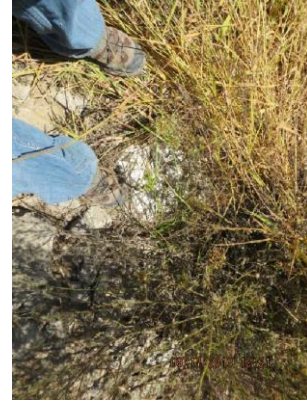
Photo 1 of 3 : UCIP\_FA\_2015\_1883.jpg

LM Start	4.70	Rating **	M	Issue No.	972
LM End	4.70	Issue Type +	En	Location *	WS
Category	Supplemental			GPS Latitude/Longitude	
				Start	End
Item	DWR UCIP Field Study			37.630815 °	37.630815 °
				-121.182416 °	-121.182416 °
DWR ID					
Action/Comments					
Inspector Comments: FS_ID:22872					
DS_ID:24676					
EP_NO: N/A					
FS_HLM: 4.746					
Repair Type: Non-Urgent					
Crossing Status: Found

PVC pipe partially visible on WS toe.

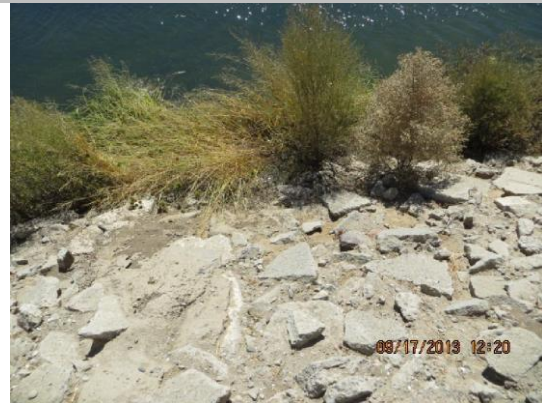
Photo 2 of 3 : UCIP\_FA\_2015\_1884.jpg

Concrete debris placed over pipe location on WS shoulder.

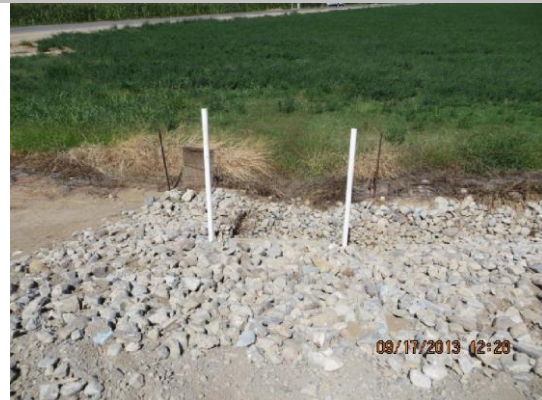
Photo 3 of 3 : UCIP\_FA\_2015\_1885.jpg

Concrete headwall at outlet on LS toe.
